Technical Report

No. 13270

DEVELOPMENT OF COST-EFFECTIVE
MANUFACTURING PROCESS FOR PRODUCING
CERAMIC TURBOCHARGER ROTORS

Robert J. Kobayashi, Robert L. Mullen
Donald E. Baker
Garrett Automotive Group,
Allied/Signal Corporation
3201 W. Lomita Blvd.
Torrance, CA 90501

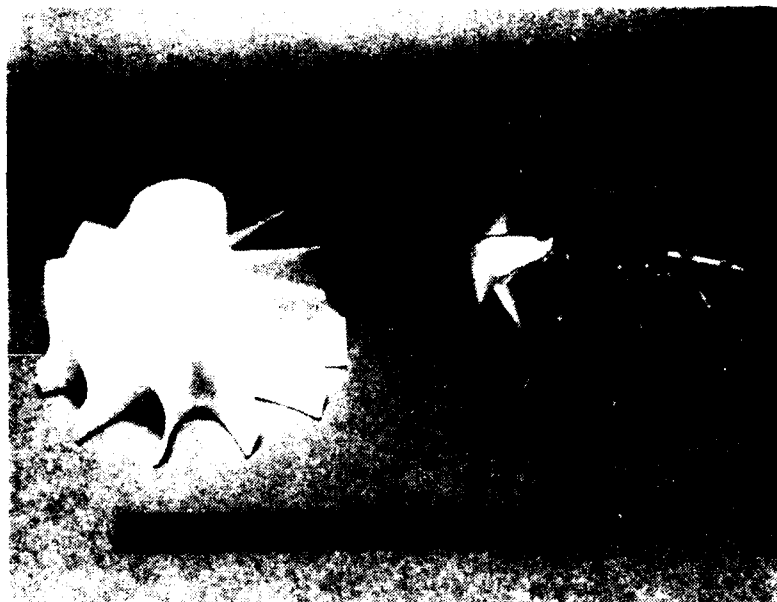
Figure 5-14. Revised TACOM Injection Wax Pattern (Left), Complete TACOM Wax Shell (Right)

In the meantime, wax and plaster mold preparation can take place. Using the TACOM rotor as the example, the actual rotor fabrication begins with the injection of water-soluble wax into patterns (Figure 5-14 left). From soluble wax injection, the wax pattern is assembled onto a tooling fixture and dipped in an insoluble wax (see Figure 5-15). The wax assembly is machined to trim off excess wax and to allow the wax shell to fit properly onto a plaster. Once machined, the wax pattern (see Figure 5-14, right) is soaked in water to completely dissolve the soluble wax pattern. The wax shell is then mounted onto a plaster (Figure 5-16) designed specifically for the machined wax shell. An alignment fixture (see Figure 5-17) is used to hold the shell in place on the plaster, allowing the symmetry of the rotor (formed by the wax shell) and the rotor shaft (formed by the plaster) to be maintained (Figure 5-18 shows assembled mold).

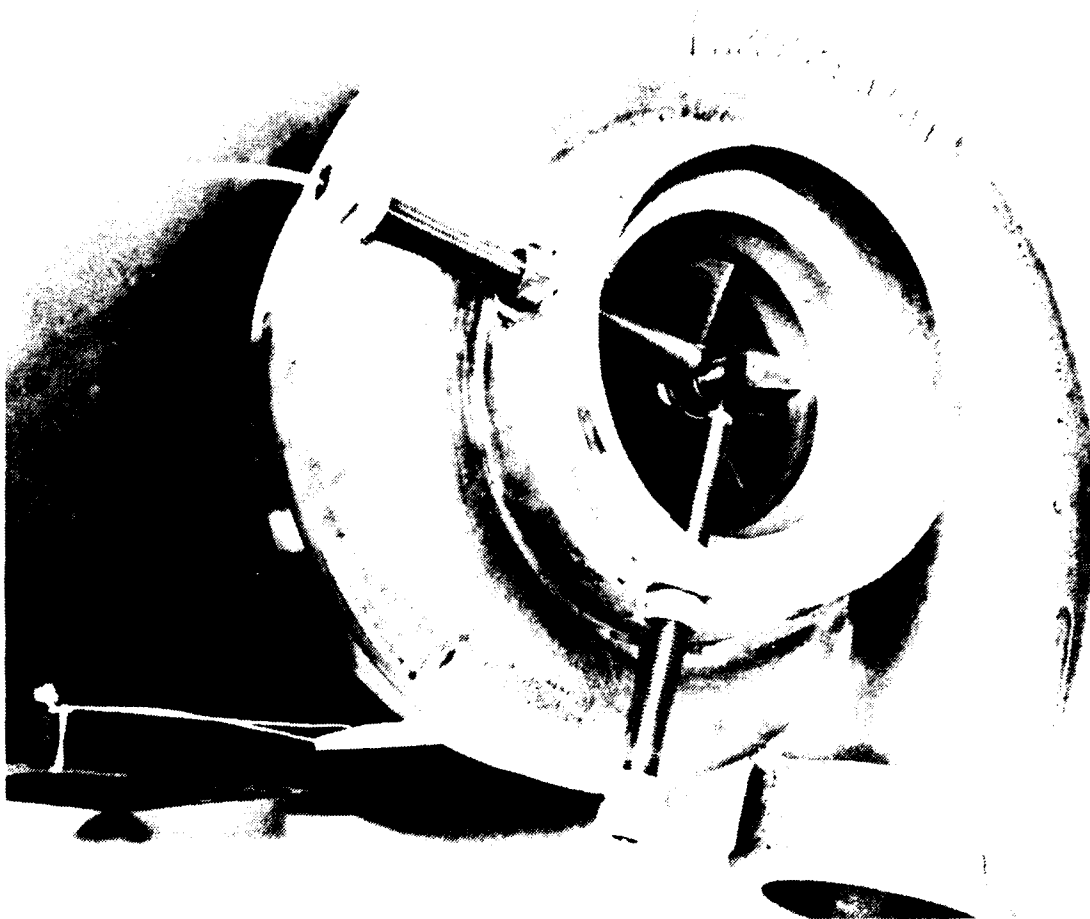
Figure 5-42. Compressor Inlet with Proximity Probes

To establish the minimum possible run-out of the special compressor nut on which the proximity probes target, the assembled center housing rotating assembly (CHRA) was put on a surface grinder and with the shaft assembly rotated, by compressed air blown on the turbine blades, the nut was ground true. A photograph of the compressor inlet with the proximity probes and special nut is shown in Figure 5-42.

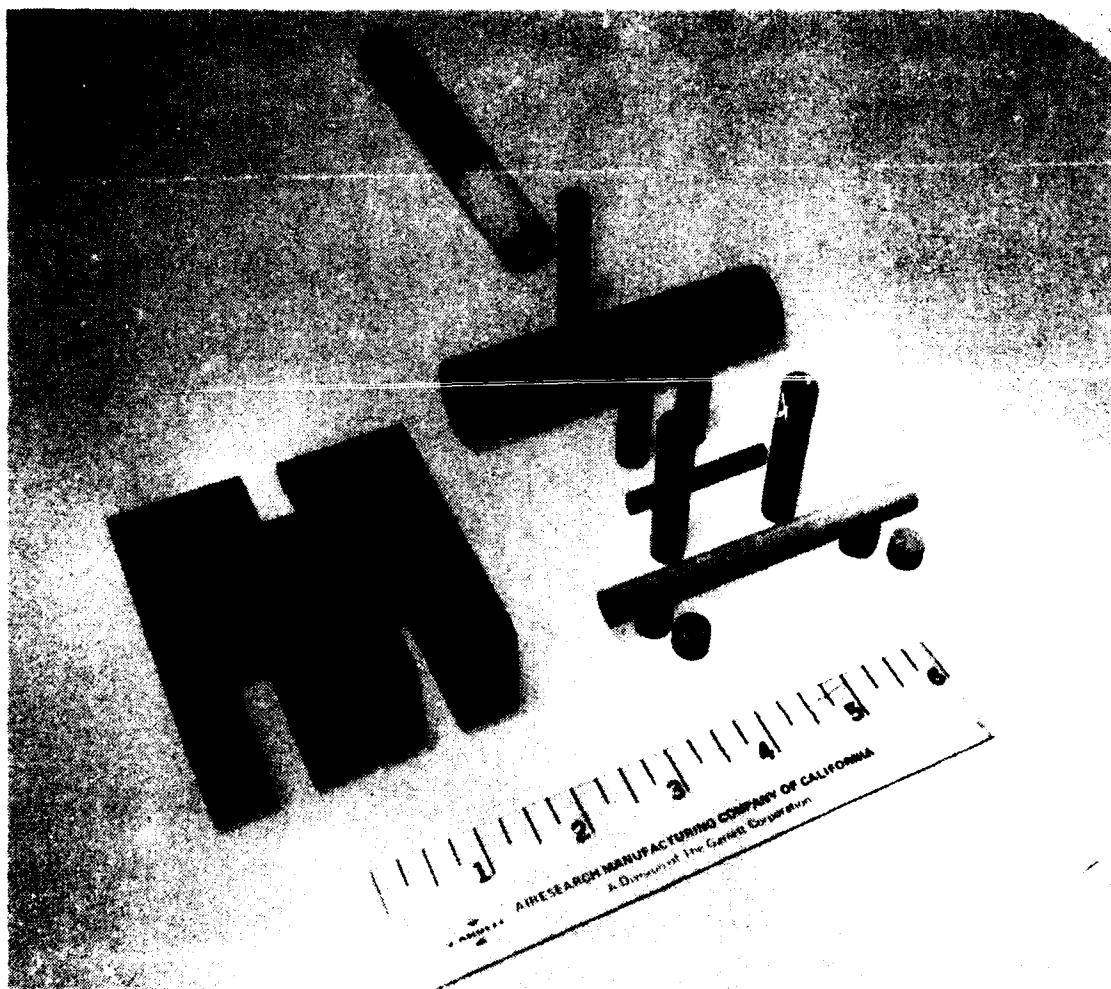
Figure 5-47. Hot/pressed Silicon Carbide Self-Aligning Fixture

Testing was conducted with a hot-pressed silicon carbide self-aligning fixture (refer to Figure 5-47). Inner and outer spans were .75 and 1.50 inches and the crosshead speed was .020 inches/min. Elevated temperature testing was conducted in air using an electric furnace (refer to Figure 5-48). Specimens were allowed to soak for 15 minutes at test temperatures of 649 C (1200 F) before loading.
